The Durability of Metal-Honeycomb Sandwich Structure Exposed to High Humidity Conditions

Andrew Rider

Airframes and Engines Division Aeronautical and Maritime Research Laboratory

DSTO-TR-1276

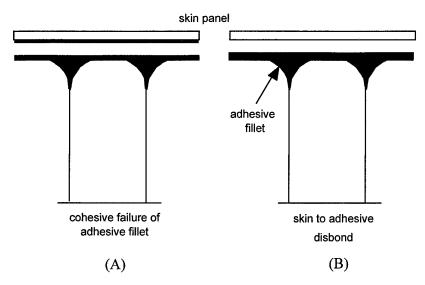
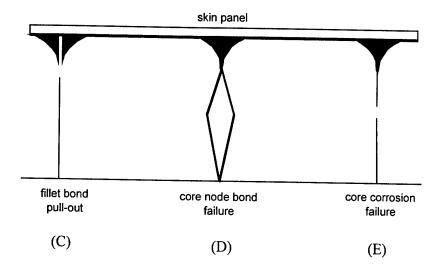
Honeycomb sandwich panels may fail in a variety of ways dependent on the weakest link in the structure. In order to provide some indication of the expected failure modes, based on previous experience[10], Figure 2.6 indicates five typically observed failure modes for metal honeycomb sandwich construction. The modes described are:

- (A) cohesive failure of the fillet adhesive, which typically represents fracture in a dry undegraded adhesive bond
- (B) skin to adhesive disbond, which indicates degradation of the interfacial bond between the adhesive and the metal skin. This is one type of adhesive failure mode.
- (C) fillet bond pull-out, which represents failure of the interfacial bond between the honeycomb core and the adhesive fillet. This is the second type of adhesive failure mode.
- (D) core node bond failure, which represents failure of the of the adhesive bond of the honeycomb core nodes. This failure may be adhesive, at the node bond adhesive and honeycomb foil interface, or cohesive, within the node bond adhesive layer.
- (E) core corrosion failure, which represents failure of the core foil material as a result of corrosion degrading the foil.

Figure 2.6 Common failure modes observed for metal honeycomb sandwich construction.

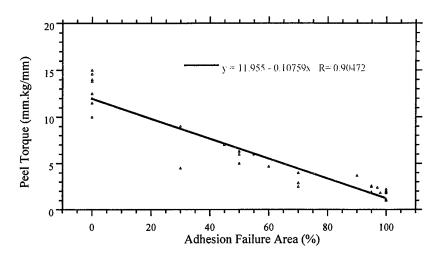
Figure 4.3.3 indicates the peel torque of the honeycomb samples tested in section 4.3.1 as a function of the adhesion failure area, which was estimated visually. The adhesional failure represents fillet-bond pullout, or failure between the adhesive and honeycomb metal surfaces. As with Figure 4.2.7, for the Elcometer failure data, there is an approximate linear relationship between the percentage of adhesion failure area and the measured peel torque.

The case for 100% cohesion failure area within the fillet bond adhesive layer produced values of 12 mm.kg/mm of peel torque or greater and 100% adhesion failure area produced a peel torque value of approximately 1 mm.kg/mm. The percentage change in peel torque between 100% cohesion failure area and 100% adhesion failure area was approximately 90%. In the case of the

equivalent percentage change for the pull-off tension samples, this value was approximately 80%, refer Figure 4.2.7.

Figure 4.3.3 Percentage adhesional failure as a function of peel torque (mm.kg/mm) for honeycomb samples tested in section 4.3.1.

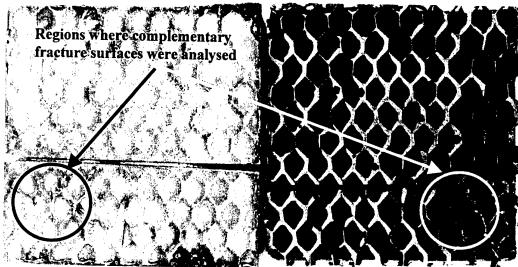
Figure 4.4.1 Failure surfaces resulting from flatwise tension testing of Hexcel CR3 honeycomb bonded to aluminium and immersed in 95°C water for 75 days.

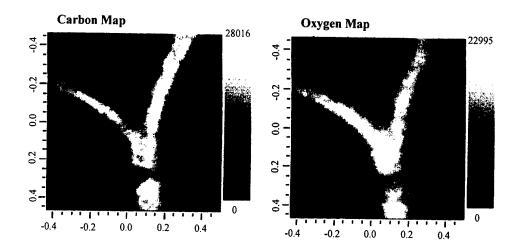
Figure 4.4.3(A) XPS maps taken on the top of the failed FWT honeycomb cell prior to argon ion etching

The fracture analysis data suggests that a thin FM-300 layer remains on the top of the honeycomb cell. Evidence for this conclusion is provided by the high carbon concentration, together with a nitrogen signal, which is typical of the chemical character of the FM-300, refer Table 4.4.1. Importantly, bromine is detected in the surface layer which is an element only present in the FM-300, hence, this acts as a marker for the presence of FM-300. The aluminium level is also quite low and the maps of the elemental distributions, refer Figures 4.4.3(A) and

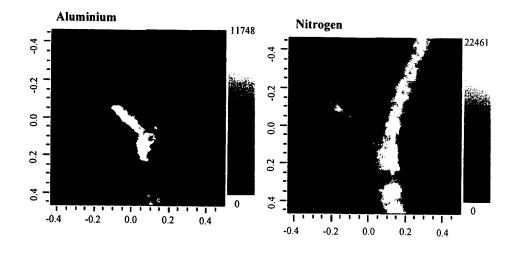
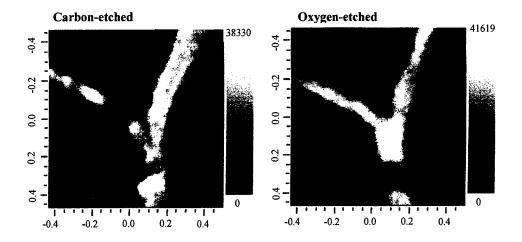
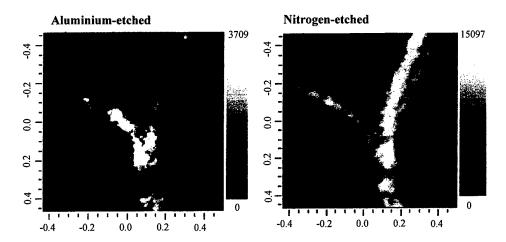
Figure 4.4.3(B) XPS maps taken on the top of the failed FWT honeycomb cell after a 30 minute Argon ion etch.

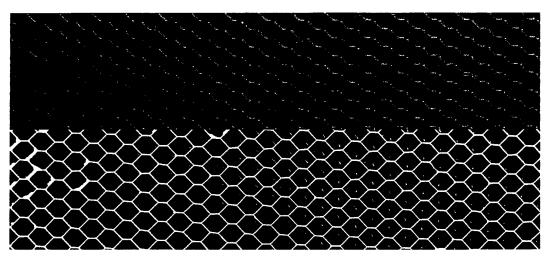
Figure 4.4.5 Failure surfaces resulting from peel testing of Hexcel CR3 honeycomb bonded to aluminium and exposed to 70° C/100%R.H. environment for 14 days.

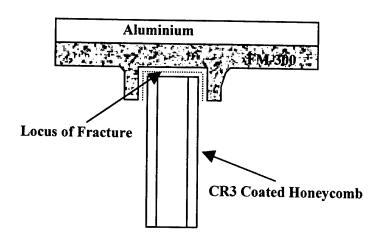
The interfacial failure mode for the fillet bond failure region of the honeycomb wall is supported by analysis of the complementary FM-300 surface, refer Table 4.4.7. The adhesive failure surface concentration is similar to that observed for FM-300 and indicates the presence of bromine, only seen in the FM-300. Two regions analysed indicate trace concentrations of chromium on the fillet adhesive surface, which may suggest that some failure has propagated into the honeycomb coating layer. The very low concentrations of chromium suggest this mode of failure only makes up a small percentage of the total locus of fracture, which appears to predominantly occur in the adhesive honeycomb surface interfacial region. The proposed locus of fracture is indicated in Figure 4.4.6.

Figure 4.4.6 Cross-sectional representation of the Hexcel CR3 honeycomb bonded to aluminium with FM-300. The dominant locus of fracture for the peel sample tested after 14 days exposure to 70°C/100%R.H. is proposed.

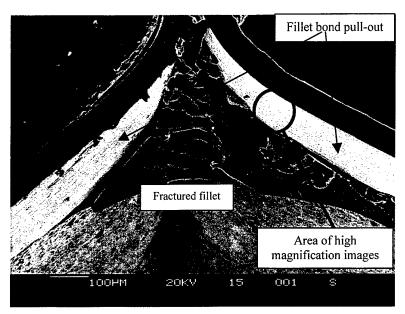
Figure 4.4.7 SEM image of the fracture surface from Alcore untreated honeycomb bonded to FM-300 and conditioned 6 months at 70^{0} C/100%RH

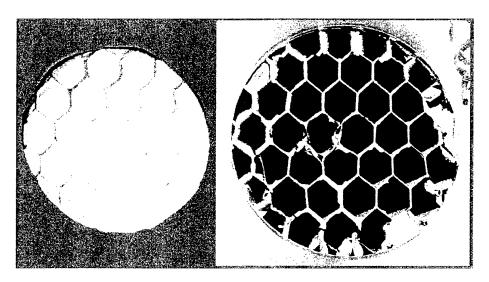
Figure 4.4.11 Failure surfaces resulting from Elcometer testing of Hexcel CR3 honeycomb bonded to aluminium and immersed in 70° C water for 6 months.

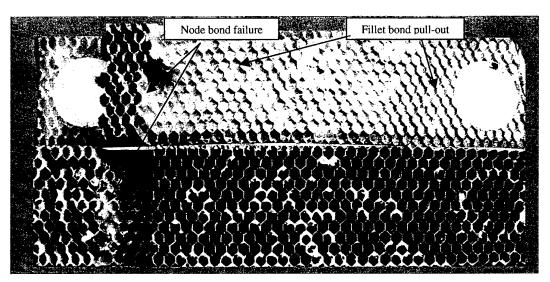
Figure 4.5.4 Failure surfaces produced by manually peeling the skin from the failed beam sample immersed 265 days in 95°C water.

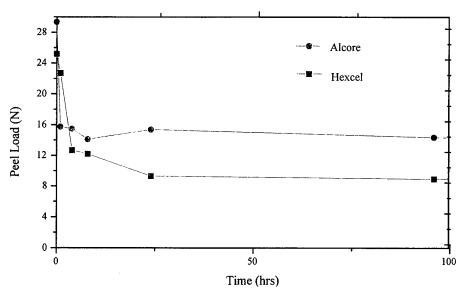
Figure 4.6.1 indicates that immersion of Hexcel and Alcore honeycomb in 95°C water results in a substantial and rapid decrease in node bond strength. The nitrile rubber modified phenolic

Figure 4.6.1 Node bond peel load as a function of time of immersion in 95°Cwater for Alcore and Hexcel honeycomb using the method shown in Figure 2.5.

The relative durability performance of the node bonds in the Hexcel and Alcore samples suggest that differences in node bond adhesive may be an important factor. Alcore node bond peel strength does not degrade as significantly in water as the Hexcel node bond, refer Figure 4.6.1, and the percentage of adhesive failure is also markedly less in the Alcore case. The strontium chromate fibres present in the polyamide adhesive of the Alcore node bonds, refer Figure 3.5, may offer more corrosion resistance than the Hexcel nitrile rubber modified phenolic node bonds, refer Figure 3.2.

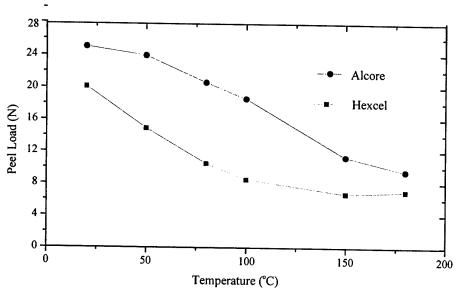
The node bond peel strength as a function of test temperature for the Alcore and Hexcel honeycomb samples is shown in Figure 4.6.2. The Alcore product indicates a superior initial strength and maintains superior performance in comparison to the Hexcel product as a function of test temperature.

Figure 4.6.2 Node bond peel load as a function of test Temperature for Alcore and Hexcel honeycomb using the method shown in Figure 2.5.

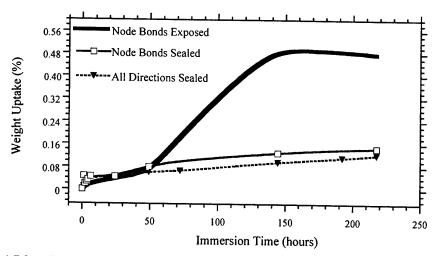
Figure 4.7.2 Weight uptake as a function of immersion time in 70°C water for Hexcel CR3 honeycomb sandwich panels bonded with FM-300.

The data suggests in the initial stages of water uptake there is a preference for diffusion of water in the direction where node bonds are directly exposed to the water. When the ribbon direction is sealed or when all directions are sealed there appears to be minimal moisture uptake.

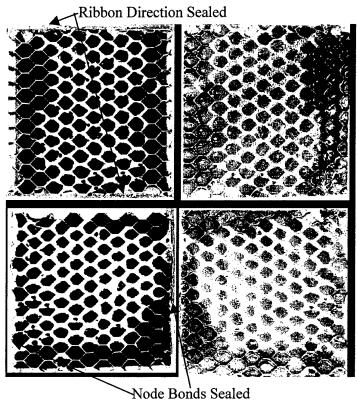
Figure 4.7.3 Failure surfaces produced after immersion of sandwich panels in 70^{0} C water for a sealed ribbon direction(Top) and sealed node direction (Bottom)

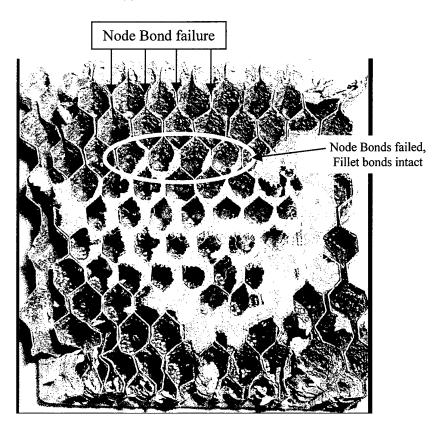
Figure 4.7.6 Failure surface resulting from immersion of Hexcel CR3 core bonded to 0.5mm thick aluminium skins with FM-300 in 70^{0} C concentrated cerium nitrate solution for 10 days.
